# Wind Effects

*Wind Effects on Buildings and Urban Environment*

# Bulletin

**Vol.6 August 2006**

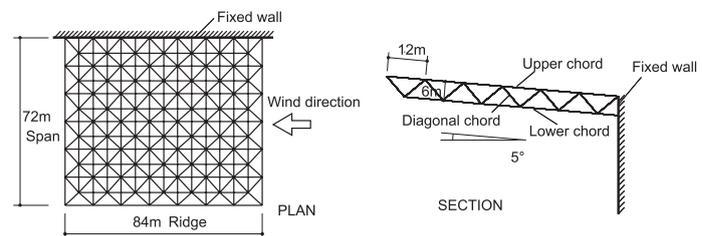
Figure 1: Large span cantilevered truss roof model

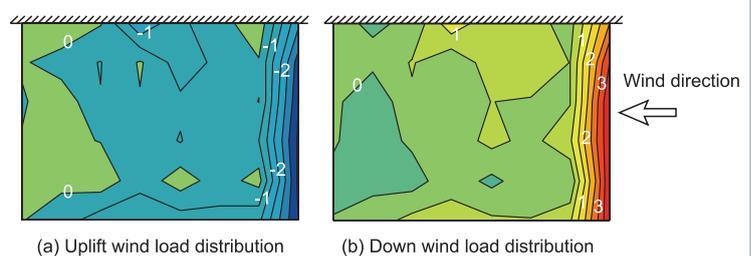
Figure 2: Universal equivalent static wind load distribution that reproduces maximum and minimum axial stress for all structural members of cantilevered truss roof

This paper describes a method for calculating the largest load effect (i.e., maximum and minimum load effect) on all structural members from a time history response analysis, and proposes a universal equivalent static wind load that reproduces the largest overall load effect. The method is then used to determine the maximum load effects for several actual cases. The goal is to provide a database of universal equivalent static wind load distributions and to develop a wind resistant design method. In practice, as the design wind load should be combined with dead load or snow load, either the maximum or minimum load effect is required to estimate the equivalent static wind load. In this discussion, the mean component is excluded from the wind load and the load effect. As the load effect can be positive and negative in the same member, all 2-powered N combinations of load effect can be considered in numbers of member N. Two combinations of largest load effects are required to determine the equivalent static wind load. One simple combination yields only positive or negative load effect. However, the equivalent static wind load reproduced by these combinations may be shown to be quite an unrealistic distribution. The largest load effect with the same sign as the mean load effect is not always shown to be a realistic load distribution. Here, a method for obtaining a more realistic universal equivalent static wind load distribution is developed. For the cantilevered truss roof shown in Figure 1, which consists of 336 members, the wind direction is parallel to the ridge. A POD analysis is applied to the fluctuating axial force calculated by time history response analysis. The sign of the largest load effect is consistent with the 1st eigen mode of the fluctuating axial force. As shown in Figure 2, the universal equivalent static wind load shows a realistic and smooth distribution.

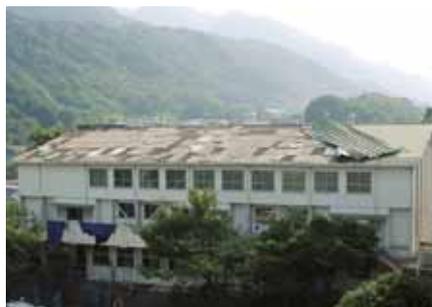
Photo 1: Damaged roof of gymnasium (T0511)

There were 23 typhoons in 2005 and 3 of them made landfall in Japan. Typhoon 0511(MAWAR) caused damage from the Tokai to Kanto districts on August 25. Post-disaster investigation was conducted for a gymnasium of a junior high-school in Hakone, Kanagawa-prefecture. Typhoon 0514 (NABI) landed at Kyushu on September 6th, passed over the Sea of Japan and landed again at Hokkaido on September 7th. According to the General Insurance Association of Japan, losses due to damage amounted to at least 65.8-billion yen. Tornadoes accompanied the typhoon in two areas in Miyazaki-prefecture. This investigation showed considerable damage due to flying debris.

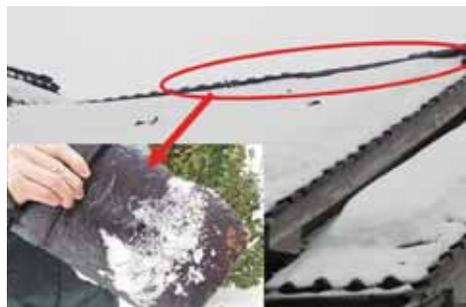
Photo 2: Damaged roof tiles at ridge (Yamagata prefecture)

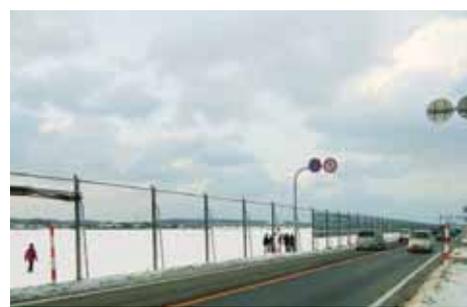
Photo 3: Damaged snow fence (Yamagata prefecture)

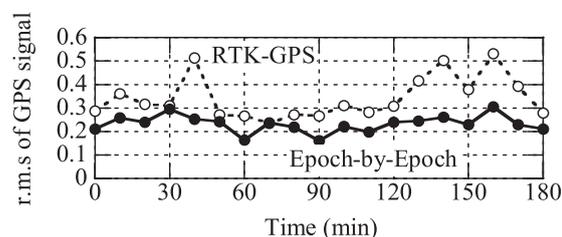
Figure 3: RMS value of GPS signal at stationary point

The accuracies of RTK-GPS and EEA-GPS were compared. Multi-GPS antennas were installed on buildings in different places to measure the responses. To transmit the structure response information, a system was constructed by which the acceleration records were uploaded to the website.

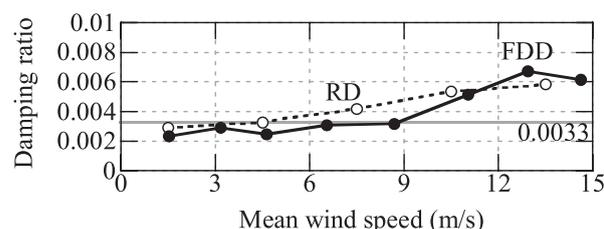
Figure 4: Damping ratio of high-rise steel tower for across wind direction

To validate the accuracy of damping estimation methods, numerical simulations were performed and the results from the frequency domain decomposition method

and the multi-random decrement technique showed good agreement with the actual values.

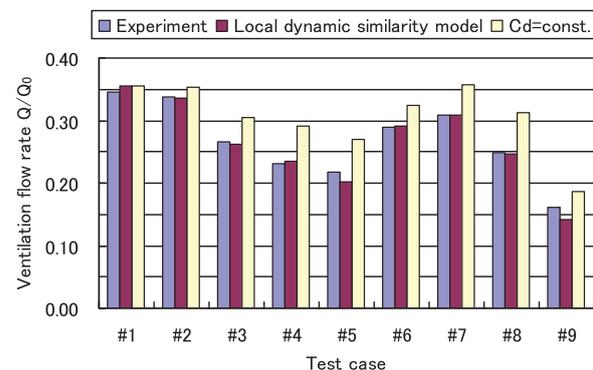
Figure 5: Measured and predicted ventilation flow rates

In 2005 we obtained the following research results from wind tunnel experiments. For outflow openings, the relations between discharge coefficient and dimensionless room pressure  $P_R^*$  are similar even when the wind directions and opening positions are varied. It is possible to estimate the discharge coefficient by a single parameter  $P_R^*$ . The tangential dynamic pressure  $P_t$  at the outflow openings was not constant, but it could be substituted by  $P_t$  measured close to the wall of a sealed building. When porosity is 16% or lower, the validity of the local dynamic similarity model is established regardless of porosity and approaching flow angle. The local dynamic similarity model coupled with a simple network model indicated better prediction accuracy of ventilation flow rates in two rooms than the conventional orifice model, as shown Figure 5.

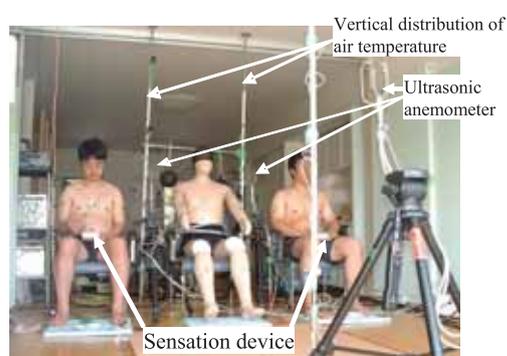
Figure 6: Field experiment on thermal comfort

It is important not only to evaluate the wind-driven ventilation environment quantitatively but also to evaluate the thermal comfort of occupants from the qualitative aspect of the airflow and from the thermal viewpoint. The project aims at a new target, i.e., to evaluate the thermal comfort of occupants in wind-driven ventilation environment from the qualitative aspect of airflow. A preliminary field experiment on thermal comfort was conducted in a condominium in August, 2005, as shown in Figure 6. The convective heat transfer coefficients on the human body and the thermal comfort of occupants in a cross-ventilation environment were investigated with two adult persons and a thermal mannequin in sitting positions on chairs. The occupants voted their feelings on airflow, warmth and chilliness and how they felt about their thermal comfort during the experiment.

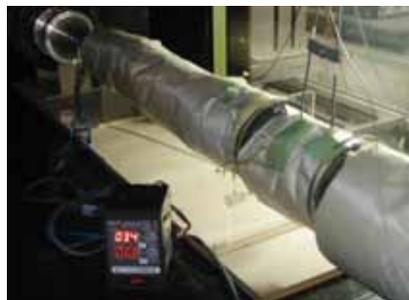
Figure 7: Calibrator for hot wire probe with different temperature

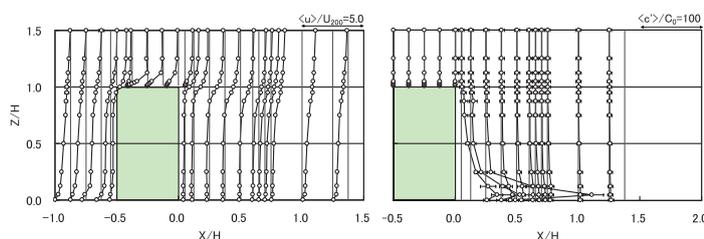
Figure 9: Measurement examples

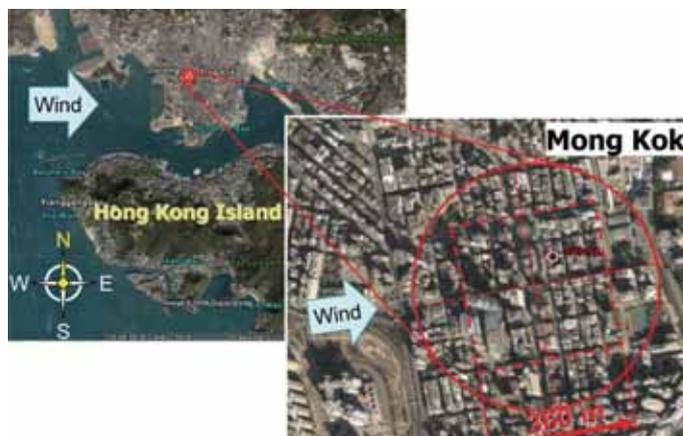
Figure 10: Modeling region of Mong Kok in Hong Kong

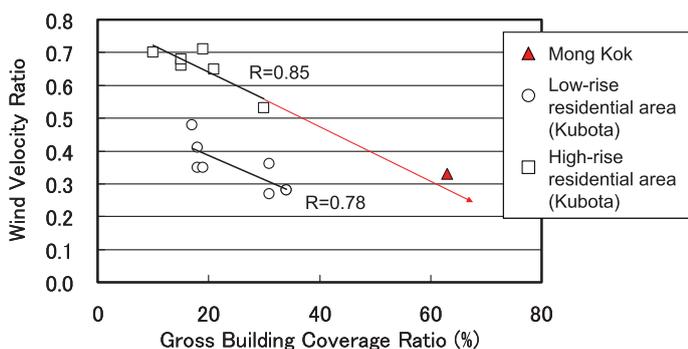
Figure 11: Relation between gross building coverage and wind velocity ratio

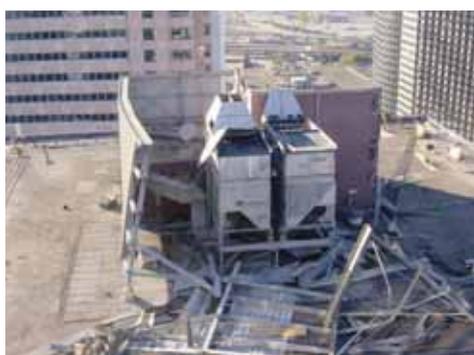
Figure 3: Rooftop penthouse on Amoco Building was nearly destroyed

– one was missing from the rooftop. It appeared that the four bolts that held the steel column to its concrete base had been sheared off. Most of the penthouse cladding had been blown off; some large components were found on an adjoining low-rise building south of the Amoco Building. *1250 Poydras*

Another cause of damage can be contributed to poor connections and lack of redundancy. This applies mostly to roof top structures. Nearly all of the damaged penthouses had missing siding at the corners associated with high levels of suction. For example, the round tower on the roof of the Hyatt was missing siding on the corners of the North face. Also, miscellaneous fasteners were found on the roof of the Hyatt among the debris. Another example of inadequate connections and bracings was the penthouse on the Amoco Building.

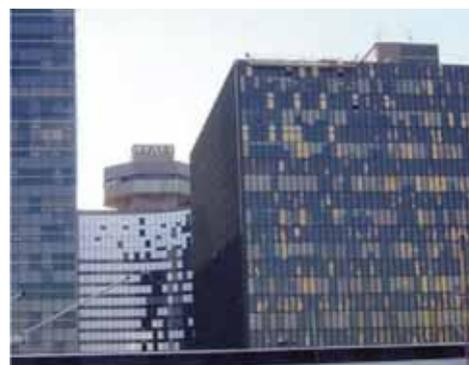
Figure 2: Damage to Hyatt Regency Hotel and Amoco Building as seen from the roof of City Hall

The Hyatt Regency Hotel, located near the Superdome, suffered significant glass and cladding damage, especially on the North face of the hotel (See Figure 2). Nearly every window on the North face of the hotel was broken as it experienced not only high winds during the storm, but wind with debris accelerating through the canyon formed by the upwind buildings. In addition, the inside of the hotel was heavily damaged: walls were torn down and room contents were scattered everywhere. Along with the

glass damage, the roof was also significantly damaged. Large portions of the roof were torn up and missing. There was evidence of abrasions on certain faces of the various roof structures, including the round center tower, and evidence of façade elements ripped off at several corners. The debris found on the property included gravel, fasteners, and large pieces of glass debris likely from other buildings upwind.

The Amoco Building sustained a large amount of glass and cladding damage as well as damage to the rooftop penthouse (See Figure 2 and 3). A large percentage of the windows were broken and were boarded up with plywood. Of the windows that were not covered, many of them showed pitting where a missile had impacted the window. The roof of the Amoco Building originally had a layer of loose pea gravel several inches thick that covered the tar surface completely. The wind blew off much of the gravel, piling some up along the South parapet and exposing sections of tar. The penthouse structures on the roof suffered considerable damage, as some of the large beams had been blown off supports and torn out of the cinder block wall. The four columns that supported the penthouse had all been pushed away from the supports

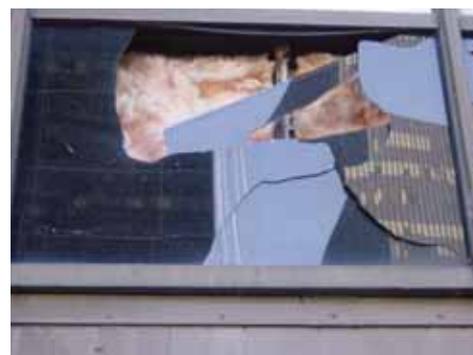
Figure 4: Broken window on North face of Hyatt Regency Hotel, likely caused by missile impact

appurtenances, siding, and penthouse structures which became airborne and caused significant damage to the glass and cladding of the surrounding buildings. The finding of gravel, glass shards, pitted glass and other debris on or inside buildings supports the scenario that the majority of the damage was caused by wind-borne debris. The breakage patterns to the spandrel glass supports the missile impact theory due to the appearance of impact holes with cracks that spread from the impact point (See Figure 4). Given the orientation of the buildings in relation to the damaged areas and the presence of gravel, it is likely that the main debris source was the gravel roofs and appurtenances of upwind buildings.

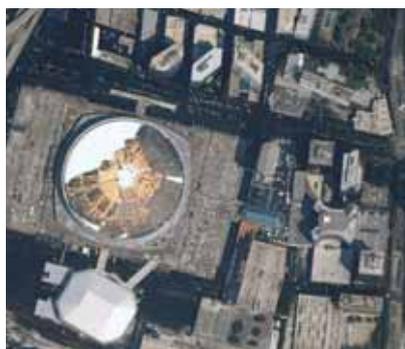
Photo 1: Business district in New Orleans<sup>3)</sup>

Photo 1 is a satellite image taken on September 3, 2005, of a group of high-rise buildings in the business district of New Orleans that were extensively damaged by strong winds<sup>3)</sup>. The waterproof sheet on the roof of the Superdome, a building about 82 m high and 210 m in diameter, was stripped off by the wind, but had been repaired at the time of our investigation. We were told that the wind stripped the roof from the direction of the portion where the waterproof sheet was not stripped off (from the northwest). Photo 2 shows the windows of the 28-story, reinforced concrete Hyatt Regency Hotel damaged by the wind. The white panels in the picture are sheets fitted into the broken windows as a temporary protection measure. The north face of the building on the windward side was damaged, and about three fourths of it was affected, independently of height. The building was less heavily and only partially damaged in the side and back faces relative to the wind direction. According to an investigation by the University at Buffalo, the State University of New York<sup>4)</sup>, it has been reported that small stones were found in all the rooms where glass was broken and that a large number of small stones that had been used to hold the roofing of the building next to the hotel to the north were missing. Photo 3 is an enlarged view of part of the damage, and shows that a balloon is projecting from a sheet as a temporary safety measure. This would have been installed to regulate flow rates on the exhaust side of

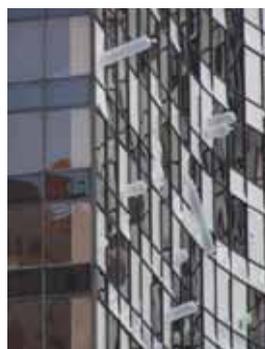
Photo 3: Detailed picture of photo 2

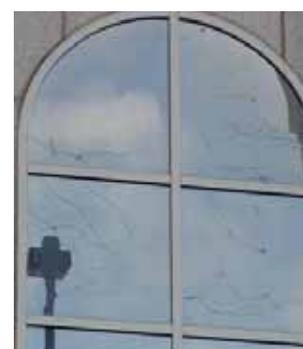
Photo 4: Breakage of windows

Breakage of windows, probably due to windborne debris, was observed in a lot of buildings over a wide area. Photo 4 shows a window on the second floor of a building, showing traces of a windborne debris. Though a crack extends from a relatively small impact scar, the window did not fall out, probably because of a safety film. Photo 5 shows a building of about 15 stories taken from the 20th floor of a neighboring building. The photo indicates that cement plates laid for roof insulation were blown out by strong winds (these cement plates, which were laid on the roof slab, may not have been anchored or glued). If blown out by wind, cement plates, which may damage the building itself or other buildings, are very dangerous.

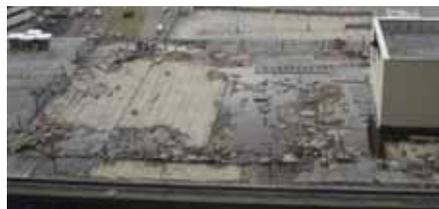
Photo 5: Slating on the roof of a building blown out by the wind

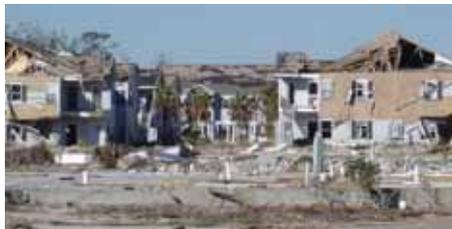
Photo 9: Houses damaged by storm surges and strong winds

While some low-rise buildings, including wooden houses, were damaged by storm surges and waves, other low-rise buildings were damaged by strong winds (Photo 9). In many cases, it was difficult to determine whether they were damaged by storm surges or by strong winds. Damage caused by strong winds was similar to damage caused by typhoons or tornadoes in Japan. For example, severe damage was observed in roof ridge tiles (see Photo 10, which shows a space under an eave with a flooding sign), and antennas, and some houses were damaged by fallen trees.

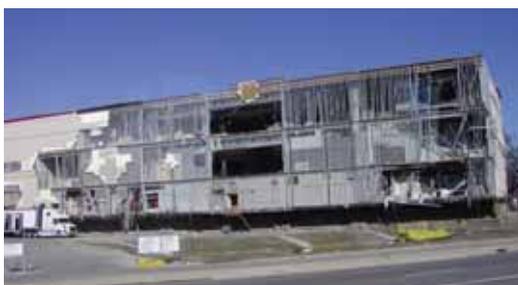
Photo 17: Floating casino washed ashore by storm surges

Photo 17 shows how a floating casino moored in Biloxi was washed ashore and damaged by storm surges. Similar damage was observed in other areas, and a ship crashed

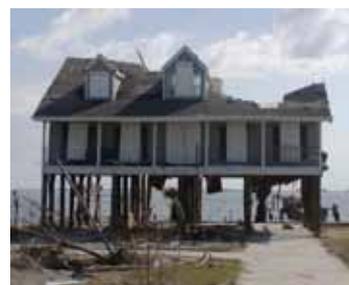
Photo 18: Damaged oceanfront elevated house

into and damaged a building. Photo 18 shows how an oceanfront elevated house was damaged. This house was only a few meters from a sandy coast. The building site was only about 1 m above sea level and there was no levee. There is a building standard in place that requires that coastal houses be built with the floor above ground level to protect against storm surges. This standard assumes that storm surges may rise under floors. This house was destroyed by storm surges above the second floor level or by strong winds. The barge, stairs, and fences of this house were also missing. Similar damage was found around this area, and many houses disappeared without leaving any trace other than their concrete bases (see Photo 19).

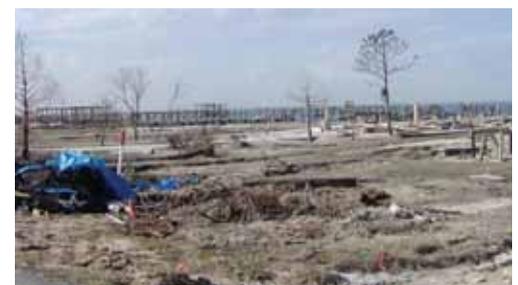
Photo 19: Trace of houses washed out by storm surges

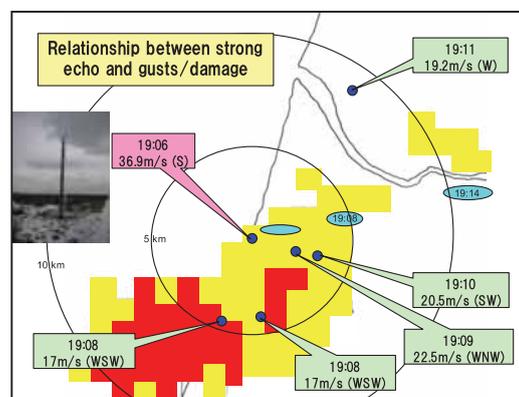
Figure 4: Strong echo area when gust attacked Sakata region at 19:10 JST, wind speed (gust) data, correspondence to damage on from the strong echoes on the ground

to the two areas, one under a cold front and the other under a northwest monsoon, appeared with developed cumulonimbus. Considering the damage on the ground and the meteorological conditions, the wind gust that struck the Sakata region is estimated to be a tornado or a local downburst (microburst) following the development of cumulonimbus.

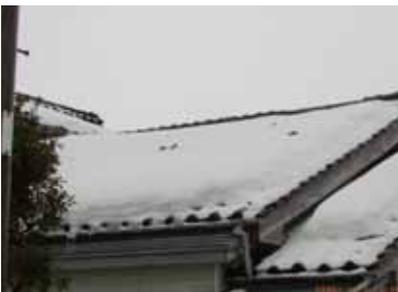
Photo 4: Damaged ridge tiles Enoki-district

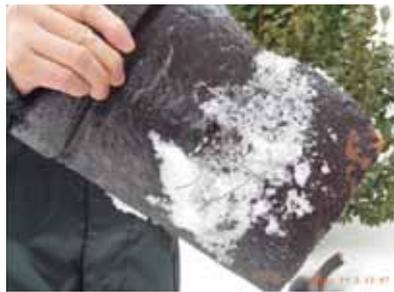
Photo 5: The damaged ridge tiles were conncted with metal wire

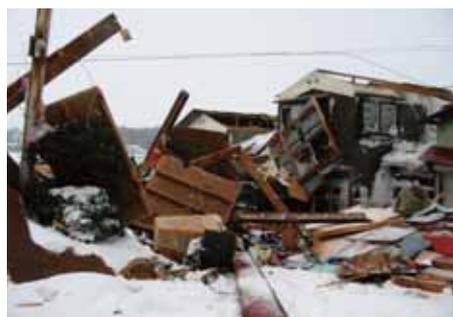
Photo 7: Collapsed wooden 2-stories office building in Osawa-district

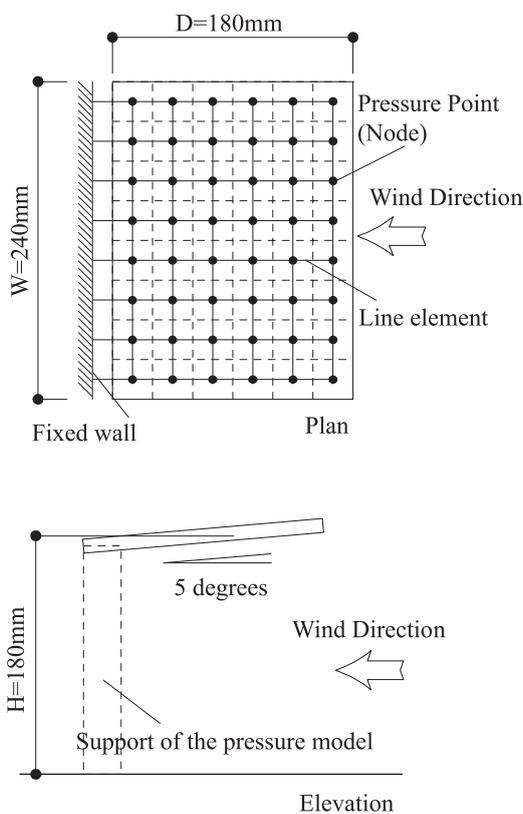
Figure 1: Large span cantilevered roof model

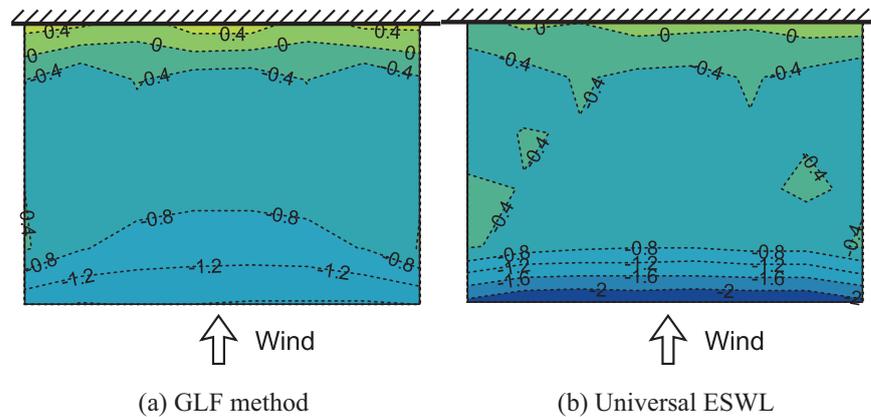
Figure 2: Equivalent static wind load distribution

Figure 2 shows the represented ESWL distributions, (a) GLF method and (b) universal ESWL reproducing largest load effects. Large negative values at windward centre are shown and the absolute values of the ESWL rapidly decrease toward the leeward side for each ESWL. The universal ESWL distribution shows a comparatively uniform distribution in the longitudinal direction

compared with the ESWL of the GLF method.

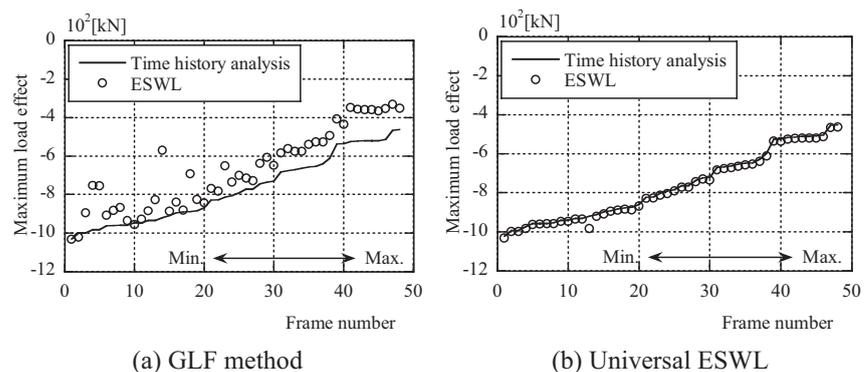
Figure 3: Comparison of largest load effect
